# YOUR INSPECTION REPORT

6160 Wood St Livonia, MI

RE: Report No. 2391, v.9 6160 Wood St Livonia, MI

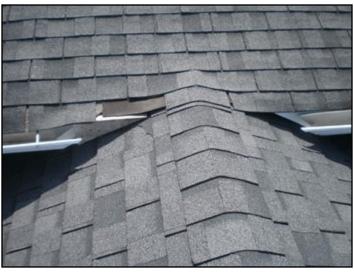
1. Asphalt shingles

**Sloped roofing material:** • The roof material seems to be not typical.

Asphalt shingles

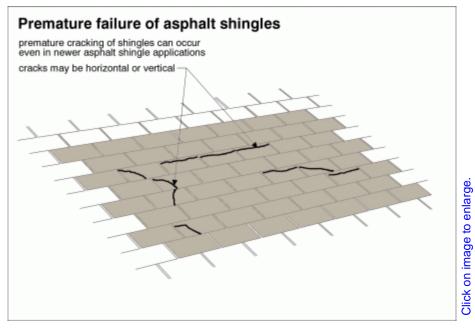
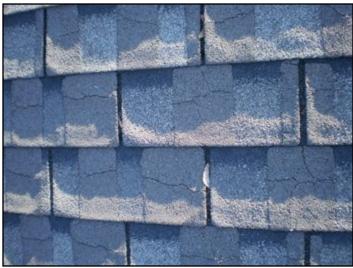
1. Condition: • Cracked

The cracking noted on most shingles is a serious defect that shortens the life of the roof dramatically. Although no evidence of leakage was notes, replacement is recommended within the next two years.

2. Cracked

Task: Replace

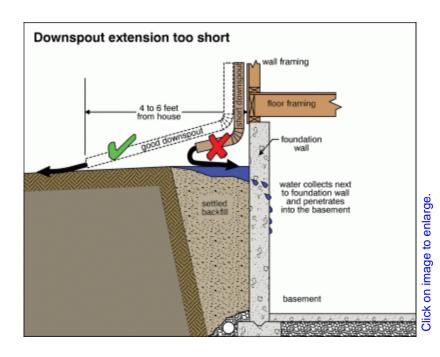
2. Condition: • Downspouts end too close to building

Implication(s): Chance of water damage to contents, finishes and/or structure

3. Downspouts end too close to building

Location: Southwest Task: Improve Time: Immediate

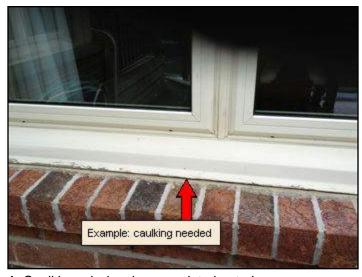
3. Condition: • Caulking missing, loose or deteriorated

Implication(s): Chance of water damage to contents, finishes and/or structure

4. Caulking missing, loose or deteriorated

Task: Repair. This is part of regular maintenance on any home.

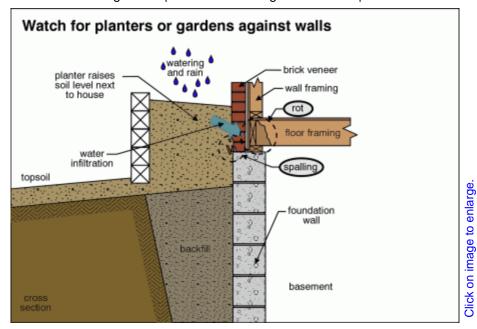
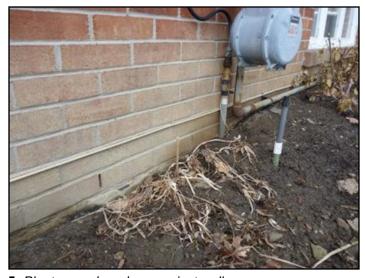
4. Condition: • Planters and gardens against walls

Implication(s): Chance of water entering house | Chance of damage to structure | Chance of structural movement

5. Planters and gardens against walls

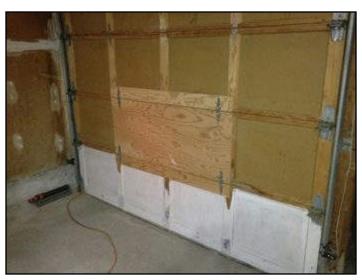
5. Condition: • Damage and previous repairs to the garage door were noted. although the door is functional, other damaged areas were noted and replacement may be preferable to regular and ongoing repairs.

6. Repairs to garage door

Location: Garage Task: Replace Time: Discretionary **EXTERIOR**

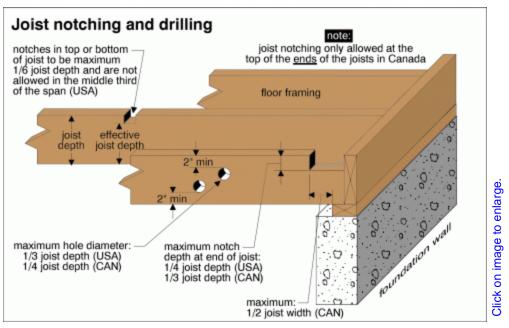
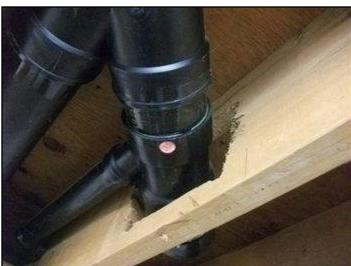
6. Condition: • Notches or holes Implication(s): Weakened structure

8. Joist damaged

Location: Rear Basement Task: Repair or replace

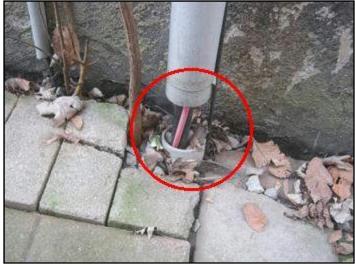
7. Condition: • Conduit or cable damaged

Implication(s): Electric shock | Interruption of electrical service

9. Conduit damaged

Task: Repair Time: Immediate

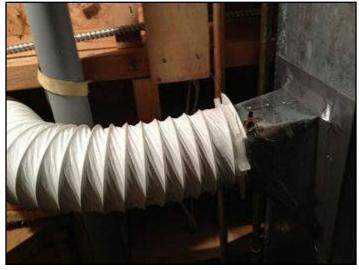
11.

10. Condition: • Inappropriate materials for supply ducting

**Task**: Replace **Time**: Immediate

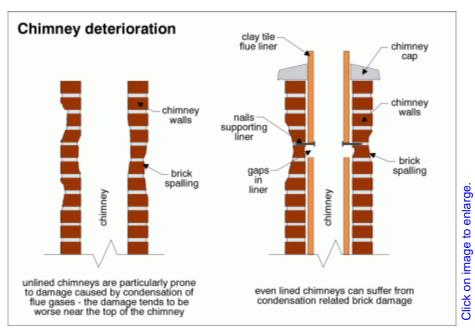
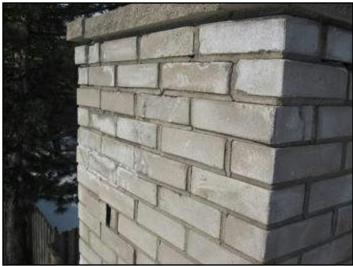
11. Condition: • Loose, missing or deteriorated masonry

Implication(s): Material deterioration

12. Loose and deteriorated masonry

Location: Roof Task: Repair

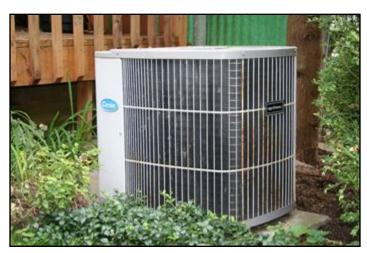
12. Condition: • Near end of life expectancy

**Implication(s)**: Equipment failure | Reduced comfort

13. Near end of life expectancy

Task: Replace Time: Unpredictable

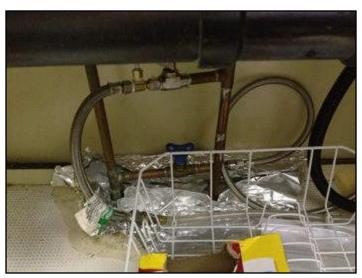
15. Condition: • Leak

Implication(s): Chance of water damage to contents, finishes and/or structure | System inoperative

**14.** Leak

Task: Repair Time: Immediate

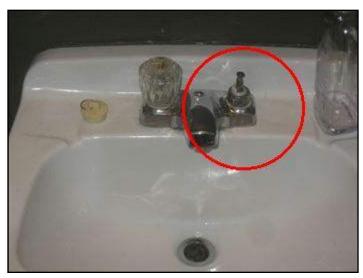
17. Condition: • Missing faucet handle Location: Front Second Floor Bathroom

15. Missing faucet handle

Task: Replace Time: Immediate

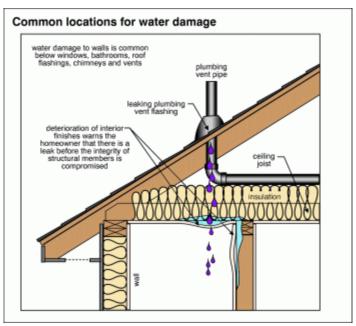
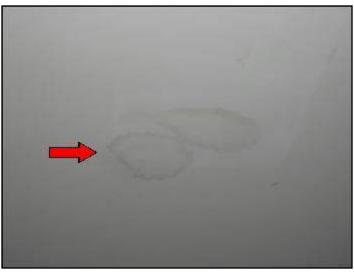
18. Condition: • Water damage

The stain on the ceiling was tested and found to be dry at the time of the inspection. The seller reports there was a leak at the chimney flashing that has been repaired.

Implication(s): Cosmetic defects | Chance of movement

16. Water damage

Task: Monitor
