Confidential Property Inspection Report

This Property Inspection was completed on August 11, 2017

Report: 1234 Not A Real Street, Philadelphia, PA, 19101

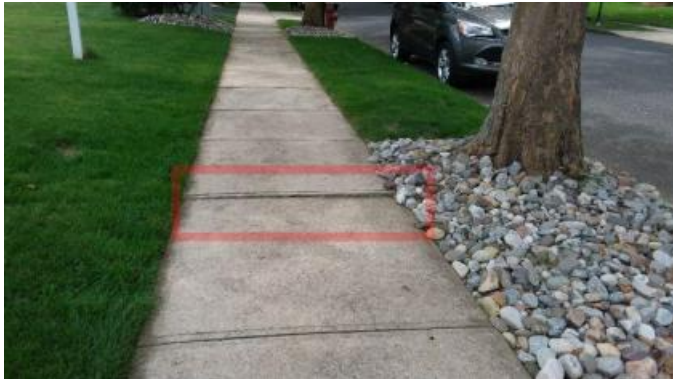
Action Necessary - The walkways need action. Repair or replacement is indicated. There is heaving noted in the walkways that needs to be repaired to prevent further deterioration or a trip hazard.

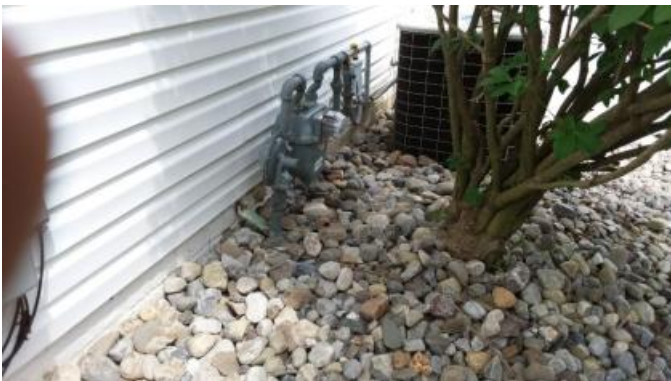
Right side of the structure. Monitor - The pressure regulator vent on the natural gas meter is low to the ground. It is important to make sure that the vent (see photo) is not obstructed by snow or debris.

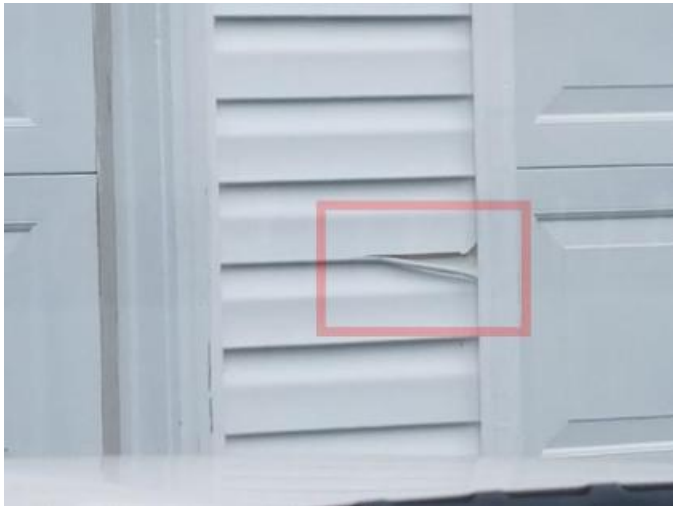
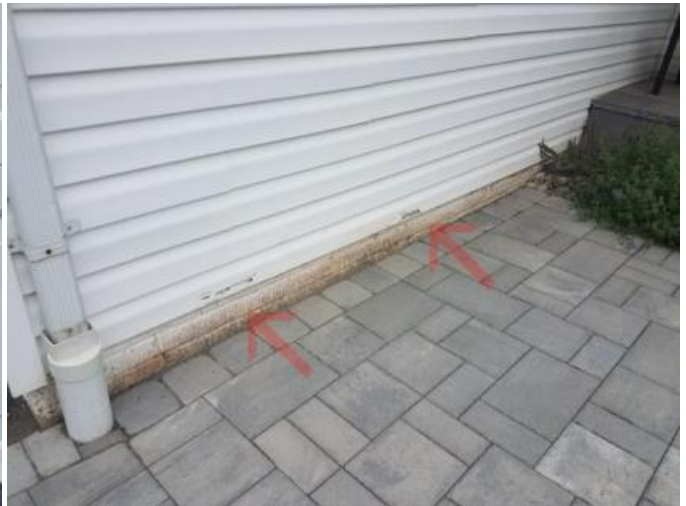
Vinyl Siding Observations - **Action Necessary** - There was one or more locations where the inspector observed some type of impact damage on the vinyl siding panels. The panels with the impact damage should be replaced.

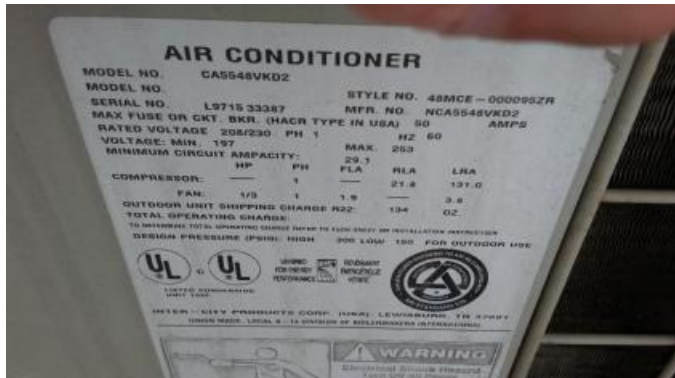
The typical service life for an AC unit is 12 - 15 years. Attention Needed - Although this unit was operational during the inspection, the age and/or condition is such that you may need to replace it in the near future. This unit was manufactured about 1997.

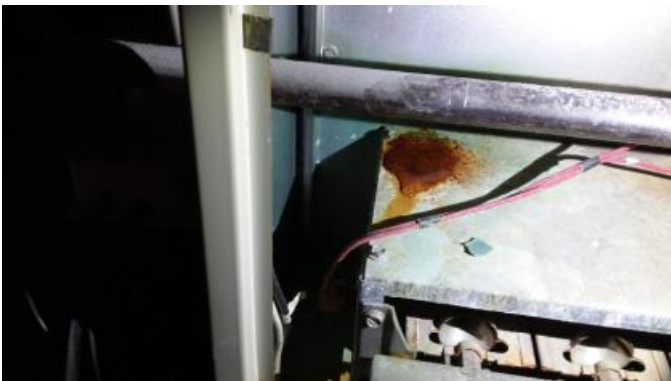
Unit was operational at the time of inspection. Attention Needed - Corrosion is noted on the inside or outside of the cabinet. There was no visible moisture in or on the cabinet. Corrosion is normally due to leaking from the evaporator coil drip pan or leaks in the condensation collection system. The inspector recommends that a qualified professional HVAC technician inspect and service the system as needed.

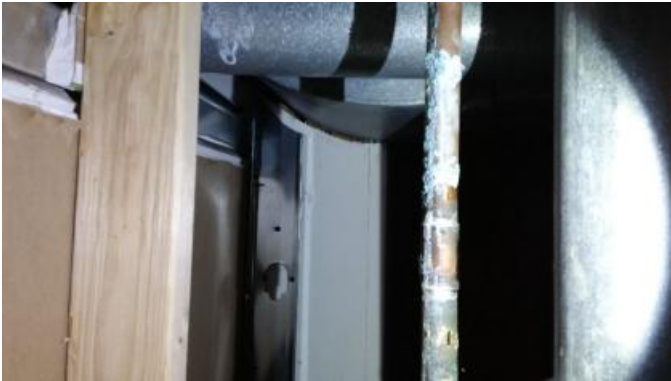
Attention Needed - There is evidence of encrustation and/or mineral deposits that may be signs of deterioration. However, no leaks are visible. Recommendation - There is no thermal expansion tank installed at the water heater. An expansion tank is a metal tank connected to a buildings water heating appliance designed to accommodate fluctuations in the volume of a buildings hot water supply system. These fluctuations occur because water expands in volume as it gets hot and loses volume as it cools. It is recommended that a plumber properly install a thermal expansion tank at the water heater.

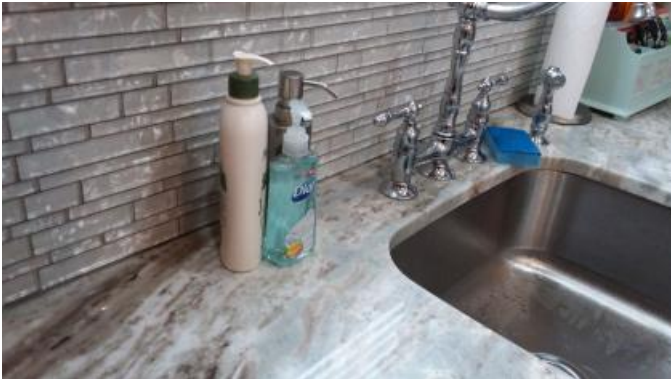
Attention Needed - The caulking in water contact areas appear to need attention. If left unsealed, water can cause costly damage.

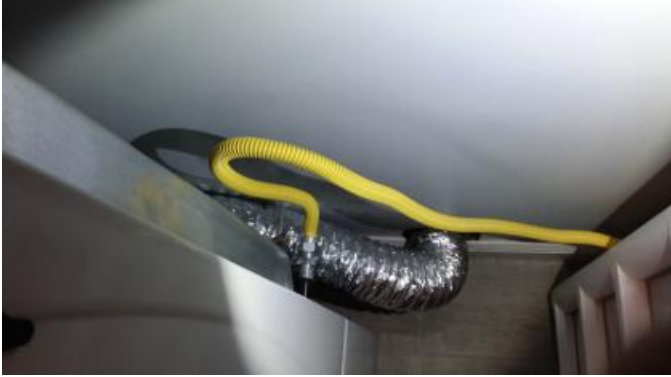
Action Necessary - The dryer ventilation as installed is not functioning properly. Action is required to make the vent work properly. Dryer vents should not be restricted. A vent clogged with lint can create a fire hazard. The International Residential Code (IRC) has the following guidelines: The dryer exhaust ducts shall be constructed of minimum 0.016-inch-thick rigid metal ducts, having smooth interior surfaces, with joints running in the direction of air flow. Exhaust ducts shall not be connected with sheet-metal screws or fastening means which extend into the duct. This means that the flexible, ribbed vents used in the past should no longer be used. The maximum length of a clothes dryer exhaust duct shall not exceed 25 feet from the dryer location to the wall or roof termination. The maximum length of the duct shall be reduced 2.5 feet for each 45-degree bend, and 5 feet for each 90-degree bend. The maximum length of the exhaust duct does not include the transition duct. This means that vents should also be as straight as possible and cannot be longer than 25 feet. Any 90-degree turns in the vent reduce this 25-foot number by 5 feet, since these turns restrict airflow. Exhaust ducts shall terminate on the outside of the building or shall be in accordance with the dryer manufacturers installation instructions. Exhaust ducts shall terminate not less than 3 feet in any direction from openings into buildings. Exhaust duct terminations shall be equipped with a backdraft damper. Screens shall not be installed at the duct termination. Exhaust ducts shall not terminate on the interior of the structure.

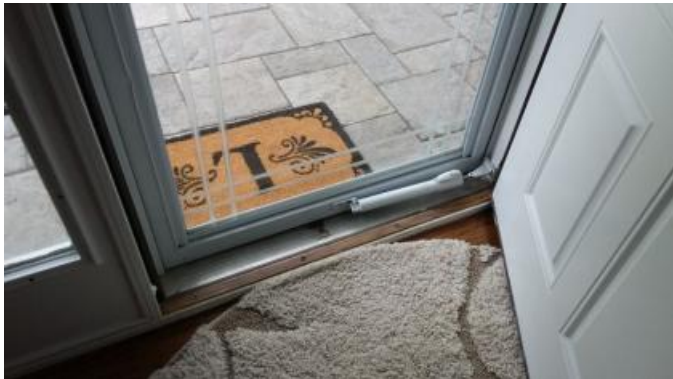
Action Necessary - There is some portion of the combination storm and screen door that needs repair or replacement.

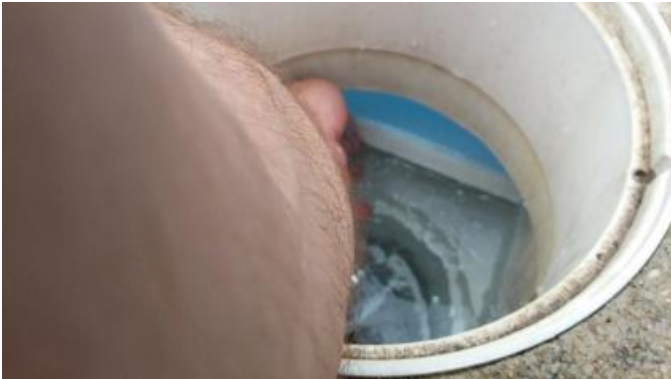
The skimmer(s), skimmer door(s), and basket(s). Appeared to be in good condition. **Action Necessary - One of the weir doors is missing the flotation on the rear of the door. This minimizes the skimming action as taking place because no surface tension is being created. The flotation must be replaced or the door must be replaced.**

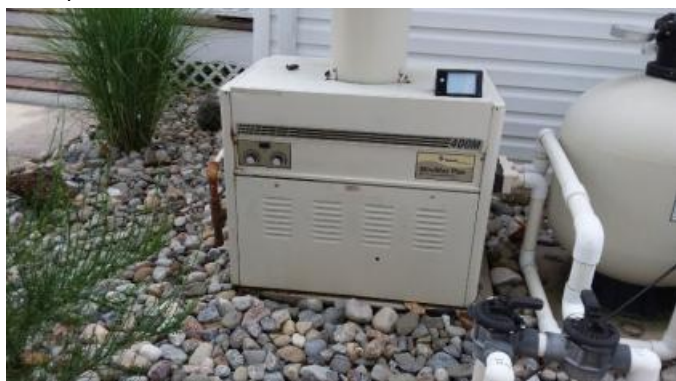
Natural gas. System has rusting within and is in fair condition, primarily due to its age. System operated properly at the time of inspection.

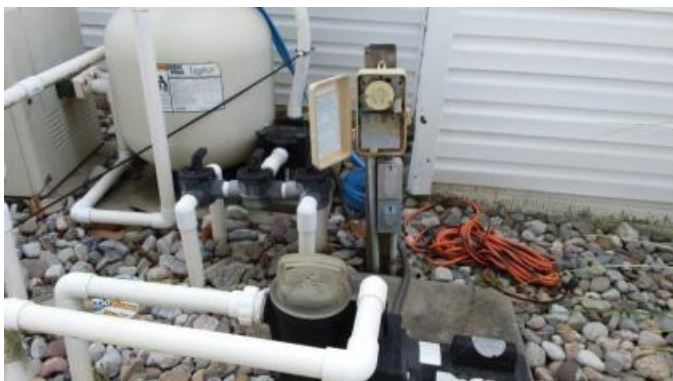
Action Necessary - The bonding wire that connected to the subpanel(s), outlet(s), switches, and timer(s) appears to be disconnected (see photo). All bonding should be thoroughly evaluated and certified to be properly bonded.

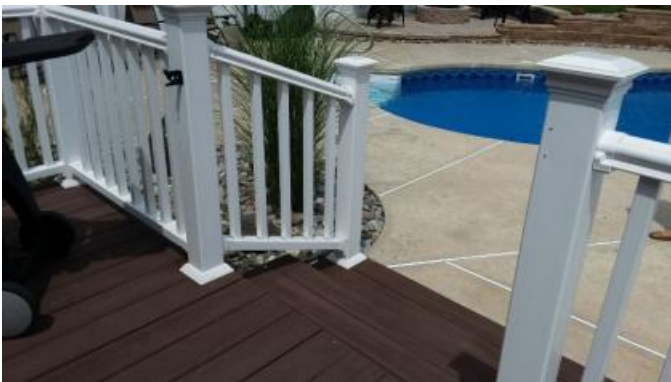
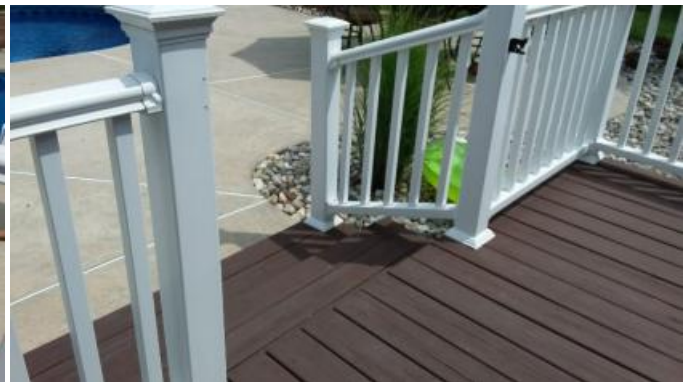
Action Necessary - Holes in the deck posts indicate a child barrier on the deck was installed in the past. The deck gates have been removed negating the child barrier from the deck. There was also no door alarm on the sliding glass door. Make inquiry with the seller about the whereabouts of any fencing materials and check with the local town Building Department as to fencing requirements with regard to the swimming pool.
