### Confidential Stucco Inspection Report

This Property Inspection was completed on August 11, 2017

**Report:** 1234 Not A Real Street, Philadelphia, PA, 19101

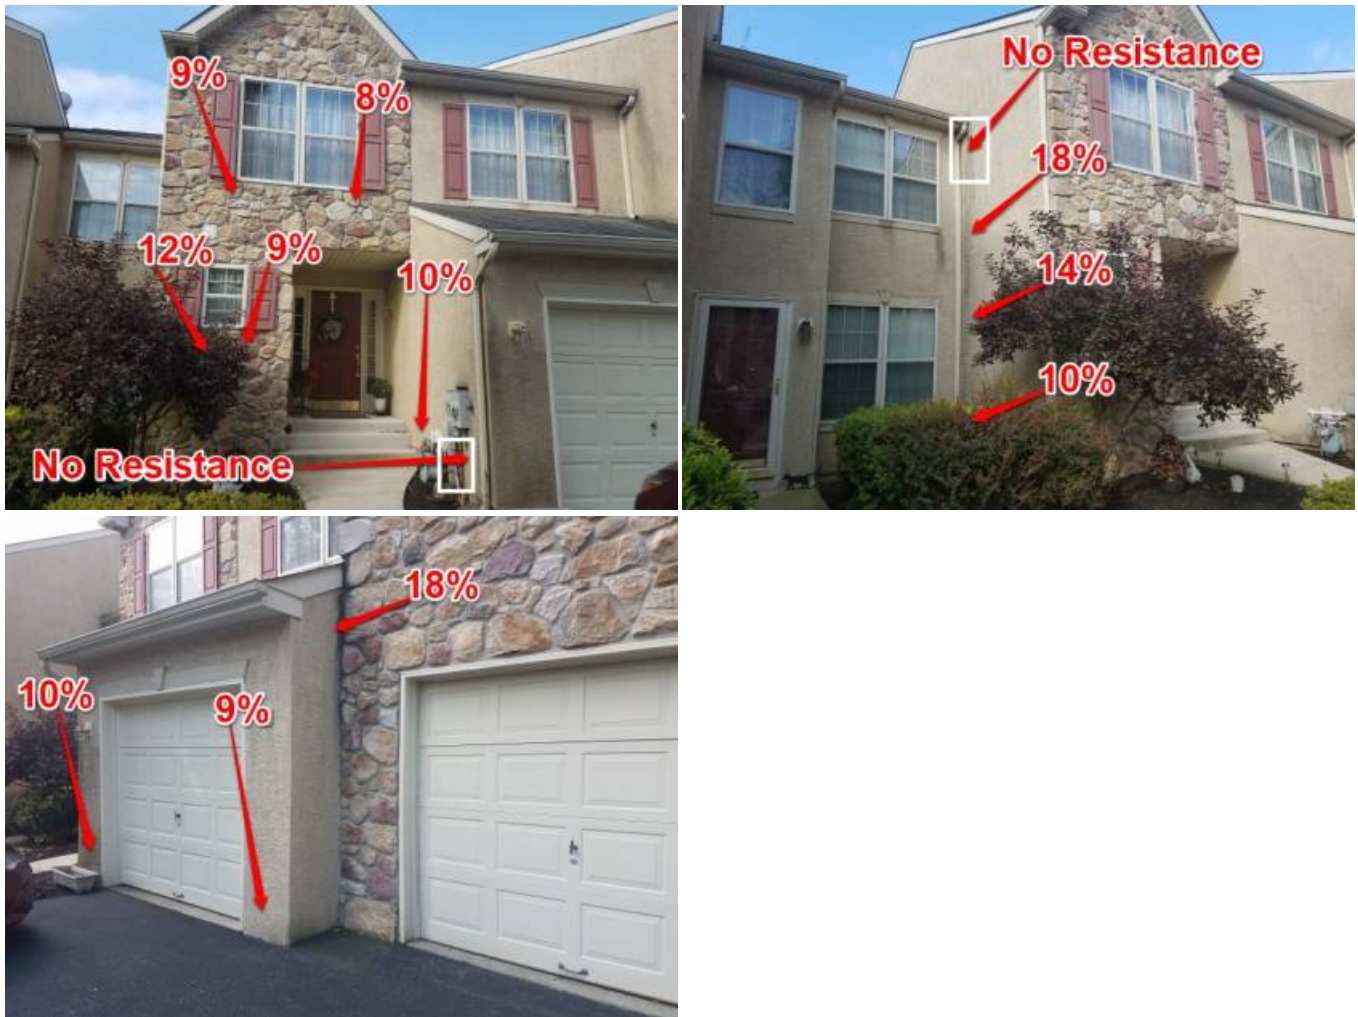
#### **Front Elevation - Moisture Mapping**

Although there were no HIGH moisture readings on this elevation, the substrate was noted to be soft and/or non-existent at the locations outlined by the white boxes. Probing in these areas does indicate that the substrate has some degree of deterioration. This deterioration has been caused by continuous moisture intrusion due to lack of proper flashing details and/or a lack of proper system sealants at penetrations in the system. The system should be opened up and the stucco removed until clean, dry substrate is found. Structural repairs should be made as needed and the system should be re-installed as per ASTM standards.

Action should be taken immediately to correct these conditions before further moisture intrusion and/or damage occurs. Specific prescriptions for remediation are outlined in the Repair & Remediation Recommendations to follow.

The locations where high moisture readings or soft substrate were noted (outlined with a white box) should be removed in a progressive manner until clean dry substrate is found. Structural repairs should be made as required and the system should be re-installed as per ASTM standards outlined herein.

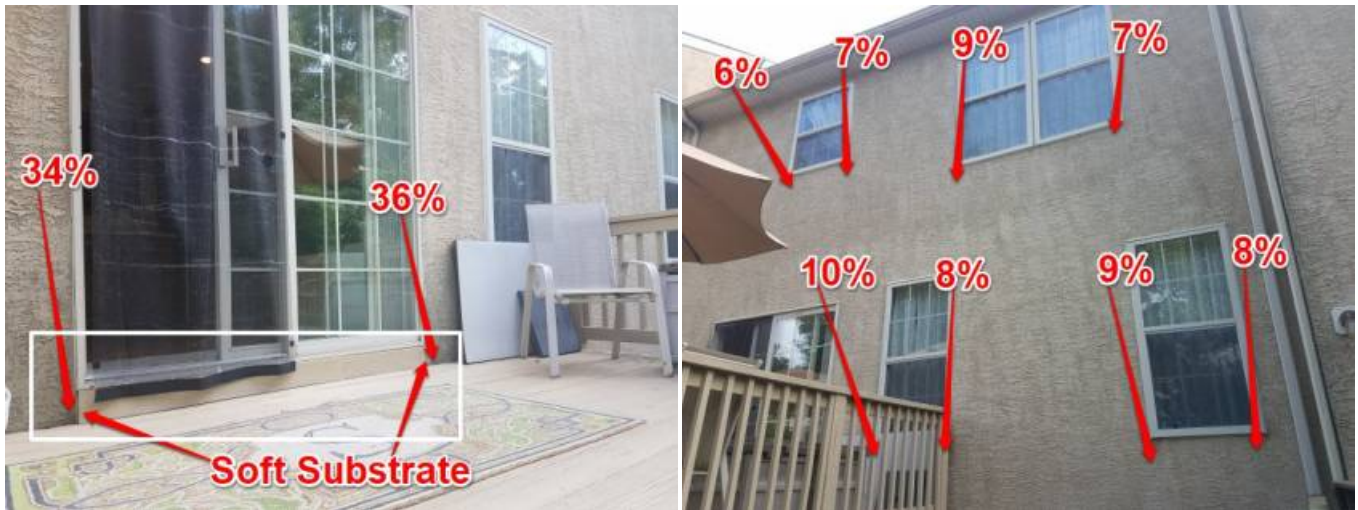
**Rear Elevation - Moisture Mapping**

There were ELEVATED & HIGH moisture readings on this elevation below the rear sliding glass door which leads from the kitchen to the rear deck. The substrate was noted to be soft and/or non-existent, indicating the likelihood of structural damage at the areas that are noted with a white box. This deterioration has been caused by continuous moisture intrusion due to lack of proper flashing details and/or a lack of proper system sealants at penetrations in the system. The system should be opened up and the stucco removed until clean, dry substrate is found. Structural repairs should be made as needed and the system should be re-installed as per ASTM standards.

Action should be taken immediately to correct these conditions before further moisture intrusion and/or damage occurs. Specific recommendations for remediation are outlined in the Evaluation Summary and narratives on the photos to follow.

The rear sliding glass door, with high moisture readings and/or soft substrates, should be removed to expose the structural components. Structural repairs should be made to replace any rotted members and sheathing. New pan flashing should be installed on the rough opening frame. The pan flashing should be sloped to allow proper water runoff and should provide a weep system. The pan flashing should be water-tight. After the pan flashing is installed, the door system should be reinstalled as per manufacturers installation details. The perimeter of the frame(s) should be sealed using self-adhered butyl flashing. The stucco system should be reinstalled in accordance with ASTM standards.

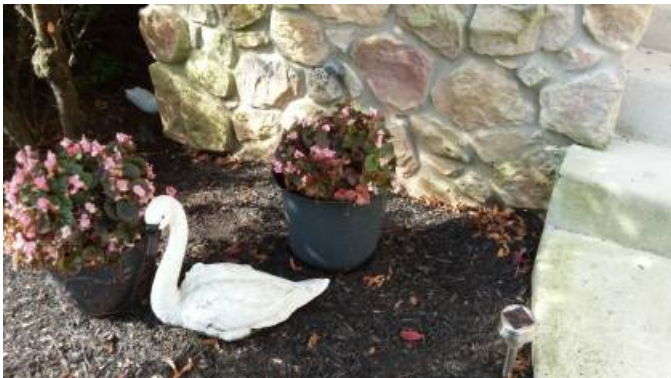
#### **Stone Veneer Grade Terminations**

Stone industry details require a minimum ground clearance of 4" above soft grade/landscaping. Stone is in close proximity to soft grade. Improper ground clearance provides means of conveyance for moisture and wood-destroying insect egress to the structure. Additionally, a weep screed or other means of drainage is required at the base of the system and was not visible.

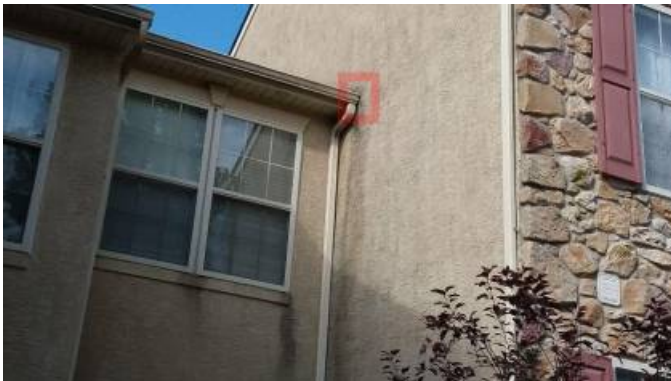
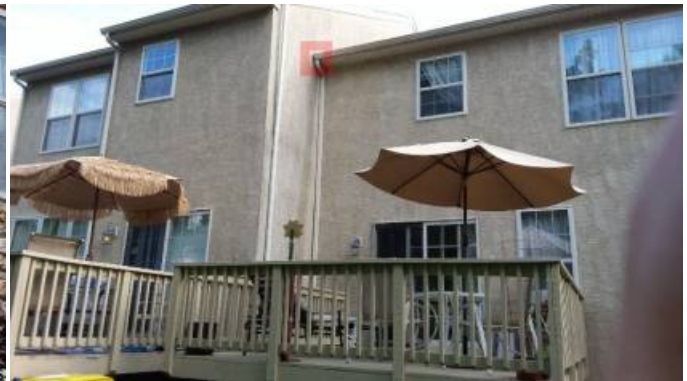
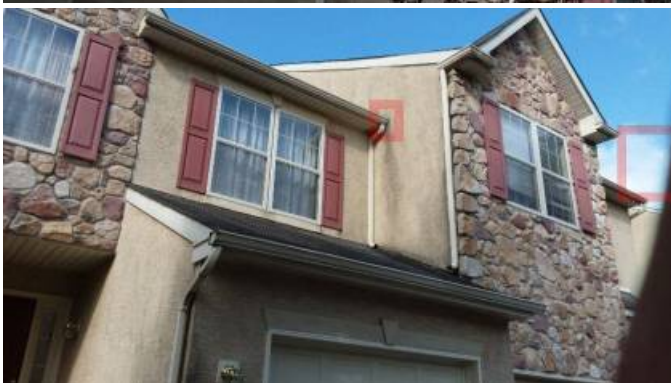
#### **Kickout Diverter Flashing @ Primary Locations**

There is kickout flashing installed at all primary kickout locations; however, the kickout flashings are poorly installed and not compliant with standard kickout flashing installation. It is recommended that the kickout flashing be removed and replaced with either a plastic Dry-Flekt type kickout flashing or a PBZ type Powder-Coated type kickout flashing and installed in accordance with manufacturer's specification and compliant with the industry guidelines as depicted on the architectural drawings containing herein.

Kickout flashing should be installed into the system according to the specifications noted herein. Kickout flashing should be installed at all primary and secondary kickout locations (secondary locations include chimneys stacks and washes, bay windows, etc). When installing kickout flashing/diverters use DryFlekt® type or equivalent. Kickout flashing should at least 6" x 6" x 12" in size. Kickout flashing should penetrate the stucco cladding and be set against the substrate with the system applied over it. The base of the kickout should be set on the roof deck with the roof coverings and tar paper set over the top of the base of the kickout. On completion both the front and back of the kickout bucket should be caulked.

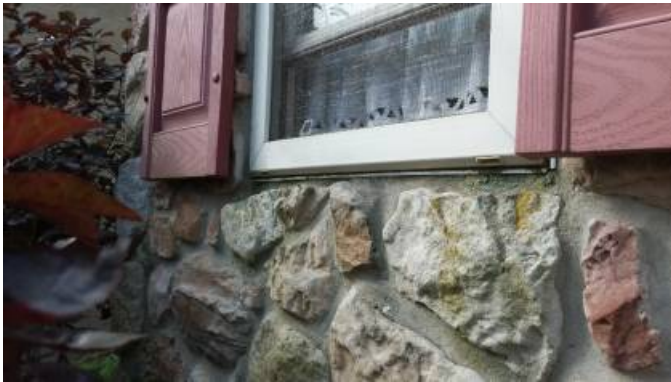
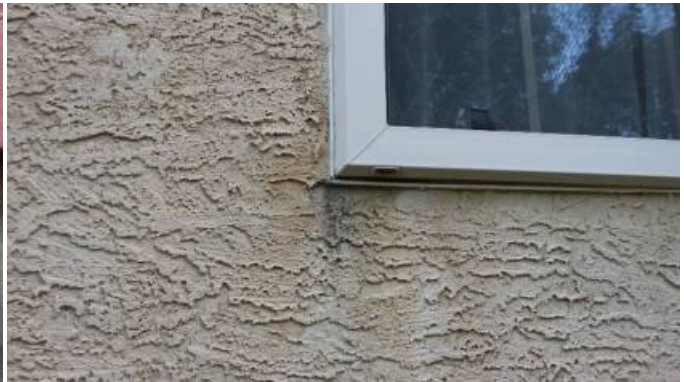
The window frames are not sealed properly. There is no bond-breaking joint or sealant around the window frames. The window frames are susceptible to moisture intrusion. The IRC Section R703.1 & R703.4 and the ASTM Standards C1063 & E2112.7 require the exterior wall envelope shall be designed and constructed in a manner that prevents the accumulation of water within the wall assembly by providing a water-resisitant barrier behind the exterior veneer and a means of draining water, to the exterior, any that enters the wall assembly. All wall assemblies must be able to prevent moisture intrusion from wind-driven rain through testing of the exterior wall envelope, including joints, penetrations and intersections with dissimilar materials in accordance with ASTM E331 (test for wind-driven rain at system penetrations).

Flashing at exterior window/door openings shall extend to the surface of the exterior wall finish (for face-sealed wall assemblies such as stucco on solid masonry) or to the water-resistive barrier (commonly behind siding/ cladding). Flashing at exterior window/door openings shall be installed according to the window/ door manufacturer installation instructions or those of a flashing manufacturer. Where not addressed by the manufacturer, pan flashing shall be installed at the sill of exterior window and door openings, be sealed or sloped to direct water out, and shall incorporate flashing or protection at the head and sides. Products used as flashing must comply with specific standards: self-adhered membranes with AAMA 711; fluid-applied membranes with AAMA 714; mechanically attached flexible flashing with AAMA 712. Head flashing is properly installed over the window frames.

Locations where the caulking was not applied correctly, where the bead was too thin or where there is adhesion failure should be repaired. Any sealant that was poorly installed or in failure should be removed and new caulking applied as per details outlined herein. The minimum width and depth of any sealant application should be ¼" by ¼". The depth of sealant may be equal to the width of joints that are less than 1/2" wide. For joints ranging from ½" to 1" wide, the sealant depth should be approximately one-half of the joint width. The maximum depth of any sealant application should be 1/2" (13 mm). If the joints are larger than 1" contact the caulking manufacturer for guidance. Backer rods or bond breaker tape should be used for all joint applications.

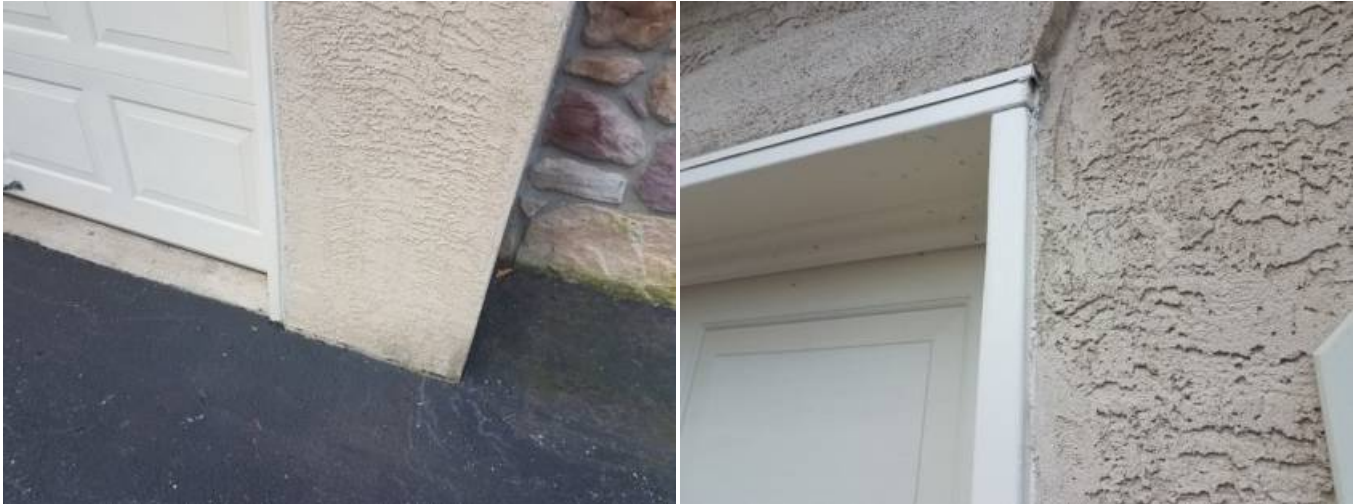
#### **Door Frames Intersecting Stucco/Stone**

The garage door frames are not sealed properly. There is no bond-breaking joint or sealant around the door frames. The door frames are susceptible to moisture intrusion. Head flashing is properly installed over the door frames.

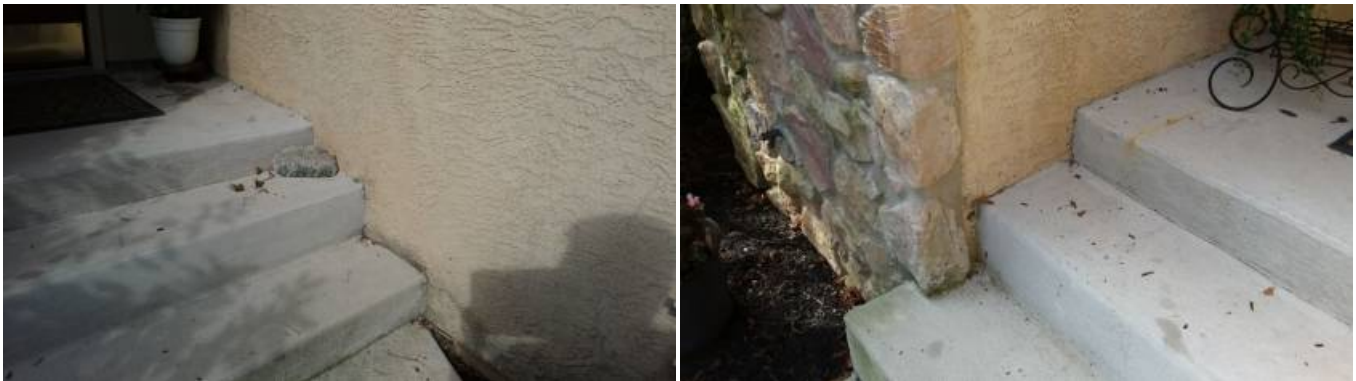
#### **Porch/Wall Flashing NOT Installed Properly**

Stucco/stone is improperly terminated on concrete porch as depicted in the attached photos. Stucco industry details require flashing at the base of the wall or, alternatively, a 2" clearance above hard surface grade with an integrated weep screed. The stucco/stone either terminates behind the concrete porch without meeting the minimum standard for proper flashing. The IRC Section R703.6.2.1 and specifically the ASTM Standard C1063.7.11.5 requires a foundation weep screed to be installed at the bottom of the wood framed exterior walls where a masonry cladding system has been applied. The bottom edge of the foundation weep screed should be not less than 1 in. below the joint formed by the foundation and framing. The nose of the screed should be placed not less than 2 in. above paved surfaces (hard grade). The weather resistive barrier and lath should entirely cover the vertical attachment flange and terminate at the top edge of the nose or ground flange.

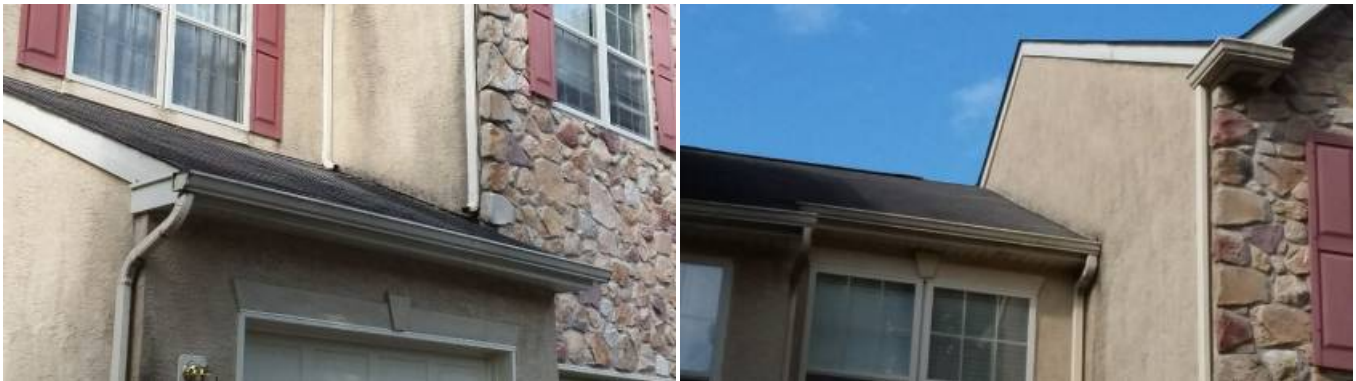
#### **No Separation @ Roof**

Industry standards require a 2" separation between the roof covering and the stucco/stone cladding. There should also be an integral weep system at the base of the adhered stucco/stone system. There is not a 2" separation between the roof & stucco/stone system. The stucco system should not be in contact w/ roof covering. The IRC Section R703.6.2.1 and specifically the ASTM Standard C1063.7.11.5 requires an integral weep screed to be installed at the bottom of the wood framed exterior walls where a masonry cladding system has been applied and intersects with a roof surface. The nose of the screed should be placed not less than 2 in. above roof surfaces. The weather resistive barrier and lath should entirely cover the vertical attachment flange and terminate at the top edge of the nose or ground flange. There is not an integral weep system installed.

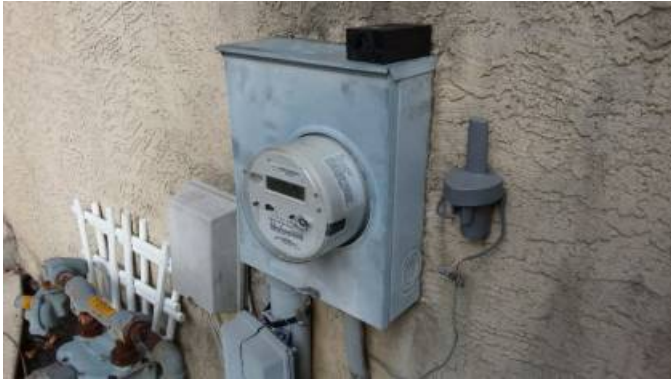
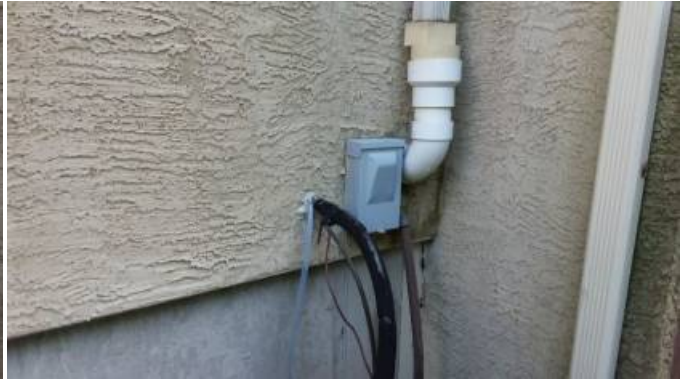
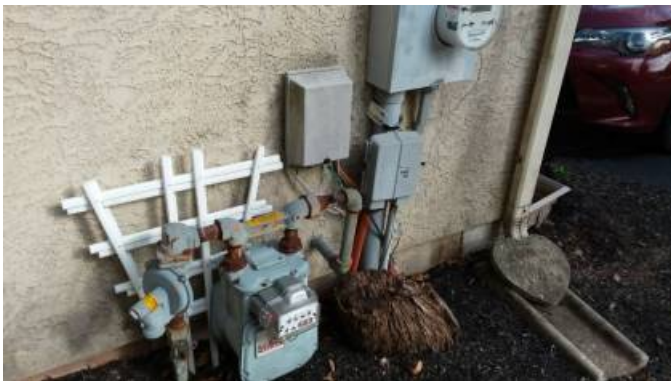
#### **Attachments & Penetrations:**

All attachments and/or penetrations are not properly sealed with approved sealant and in a manner that is in accordance with industry standards. All system penetrations such as light fixtures, electrical outlets, and utility conduit or utility boxes should be properly attached and/or sealed with a manufacturer-approved sealant to prevent moisture intrusion. A proper fillet bead of sealant should be applied at ALL penetrations and attachments. The sealant should exhibit a minimum surface contact area of 1/4" onto each surface and have a depth of at least 1/2". The IRC Section R703 and the ASTM Standard C926 and C1063 require design considerations that provide sealing or caulking at all penetrations, attachments, and intersections with dissimilar materials to prevent the entry of water.

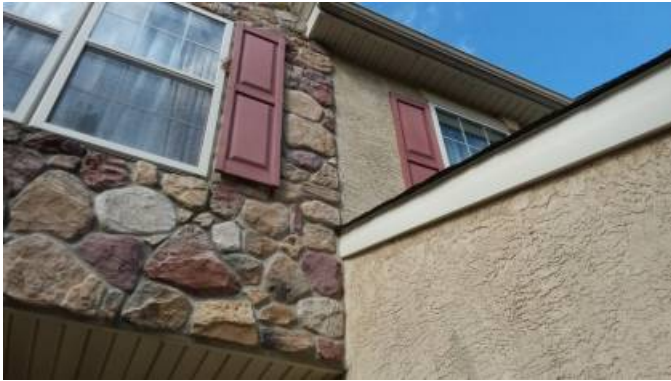
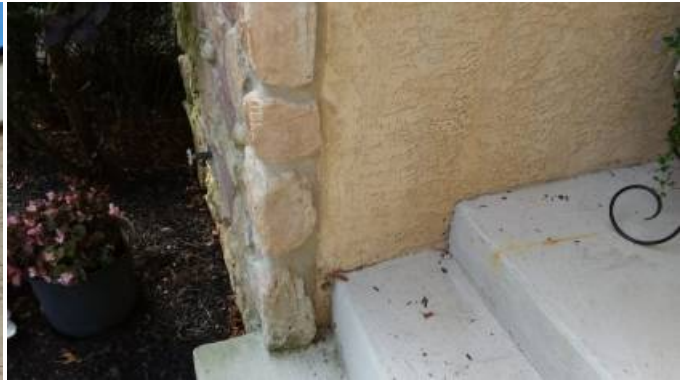
#### **Intersection @ Other Siding NOT Sealed Properly**

The intersection with other types of siding is not sealed properly. Vertical joints with other types of siding should be sealed with a bond-breaking joint that allows for expansion and contraction of the dissimilar materials while ensuring a water tight seal. The IRC Section R703 and the ASTM Standard C926 and C1063 require design considerations that provide sealing or caulking at all penetrations, attachments, and intersections with dissimilar materials to prevent the entry of water.

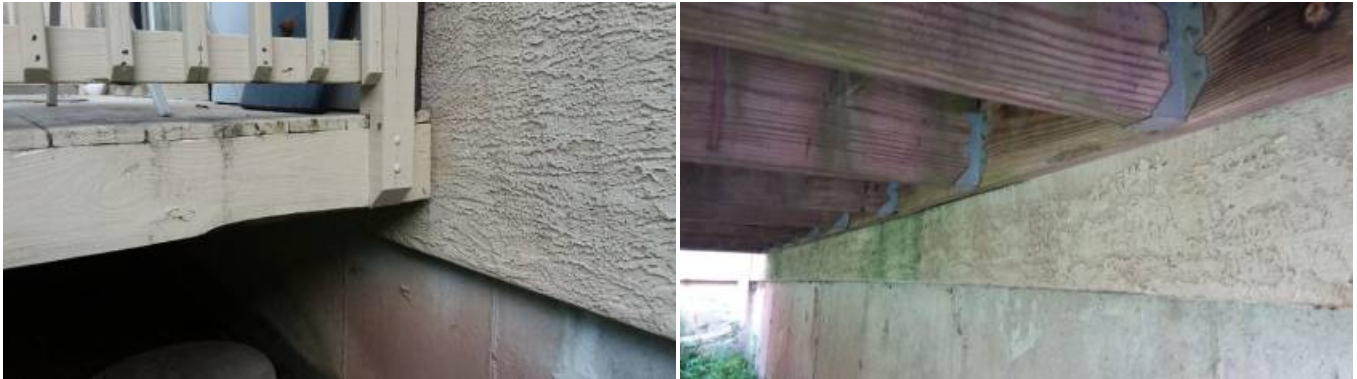
#### **Deck Flashing:**

The deck ledger is a surface mounted deck system. The deck bolts penetrate through the ledger board and into the rim joist of the structure.

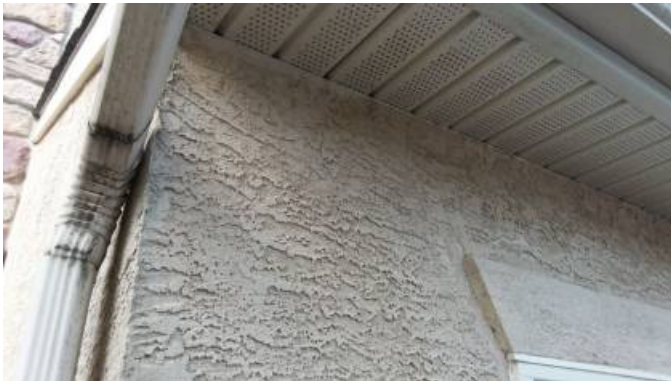
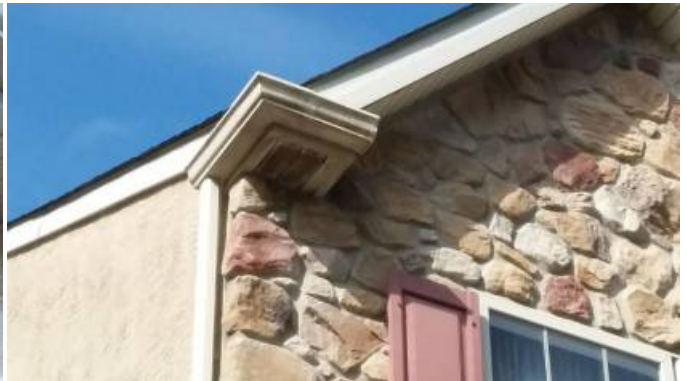
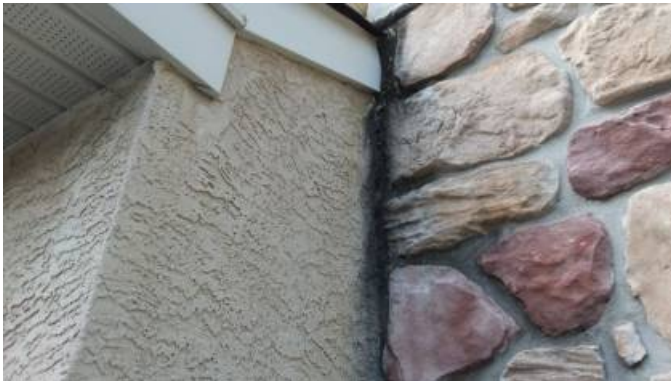
#### **Soffit/Fascia/Rake Intersections:**

The stone/stucco intersection with fascia/rake board is not adequately sealed. Stucco industry details require fascia/rake boards to lap over stucco a minimum 1". Or alternatively, if stucco is abutted to fascia/rake it should be sealed to prevent moisture intrusion due to wind-driven rain.

Stucco industry details require soffits/fascia/rake boards to lap over the masonry cladding by a minimum of 1". If this standard is not met, these terminations with the cladding system must be sealed to prevent moisture intrusion due to wind-driven rain.

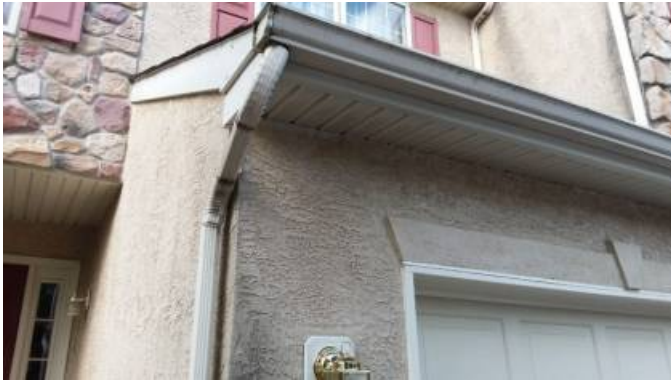
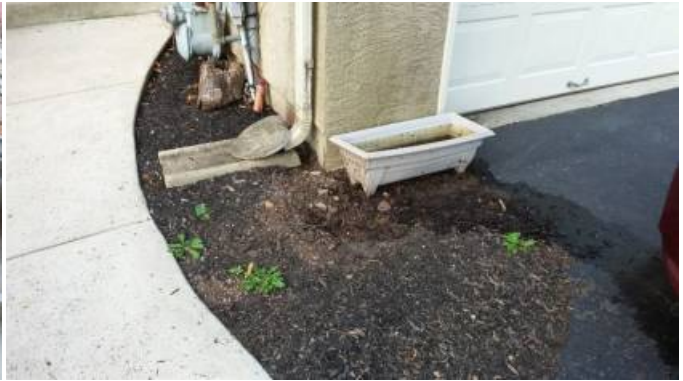
#### **Rainwater Conductors:**

The rainwater conductors (gutters and downspouts) were not functioning properly. All gutters must be installed properly and be free of debris. The downspouts must be properly attached to the structure. All downspouts joints should be secure and the downspouts should terminate at grade either in an underground impervious water collection system or onto splashblocks that can disperse the water at least 6 feet away from the foundation.

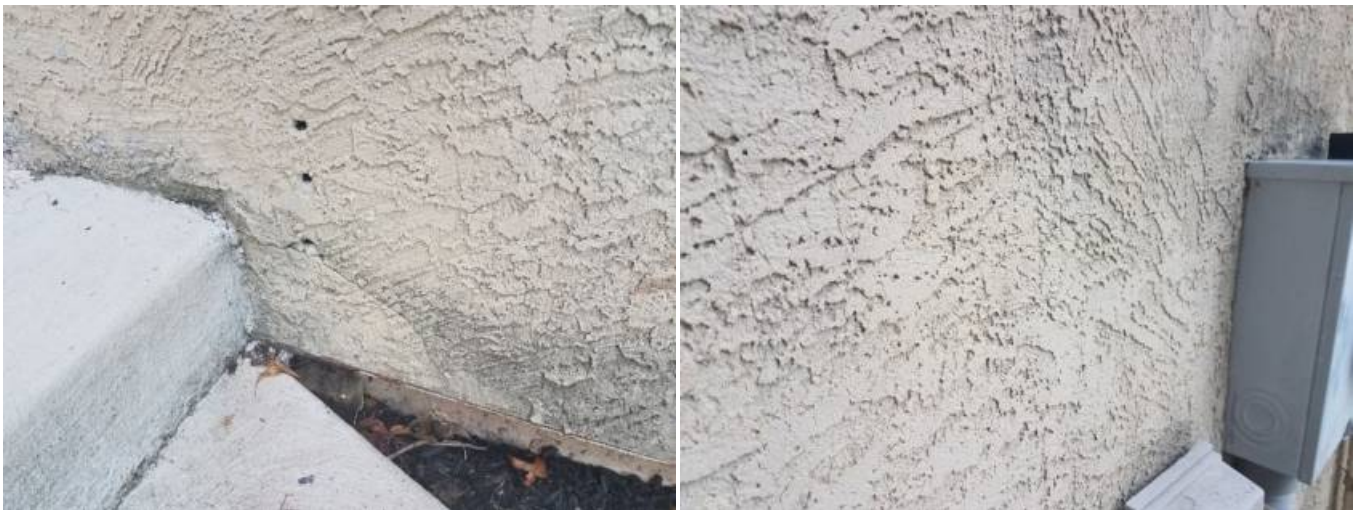
### **Cracking:**

Cracking was noted at numerous locations throughout the system. Compression cracking in stucco systems is usually related to the absence of proper control joints. The stucco system should be inspected regularly and any cracks that are found should be sealed to prevent further moisture intrusion.

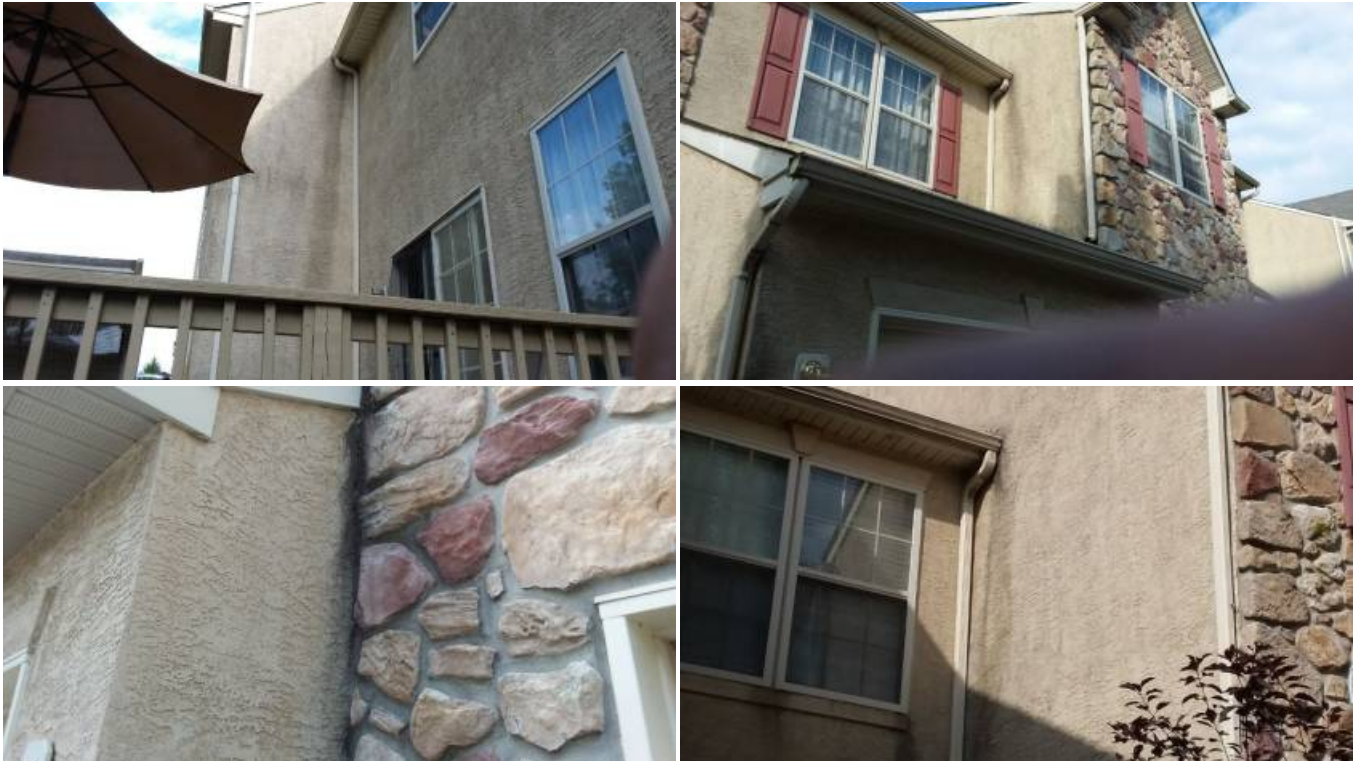
Staining on the stucco/stone surface may or may not indicate a problem exists. When staining is present further investigation is always required. We highly recommend a Level 2 Stucco/Stone/EIFS Inspection with moisture probing and mapping.
