Confidential Property Inspection Report

This Property Inspection was completed on August 11, 2017

Report: 1234 Not A Real Street, Philadelphia, PA, 19101

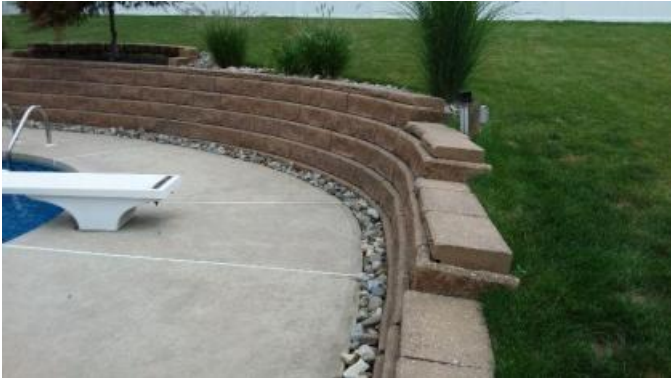
Attention Needed - The retaining wall requires some repair which is due either to movement. The retaining wall is leaning and considered to be in failure; however, the wall is leaning backwards and it is not being pushed forward from ground pressure. The wall should be monitored for future movement. If any movement is observed, the wall should be disassembled and reassembled using proper anchoring technology.

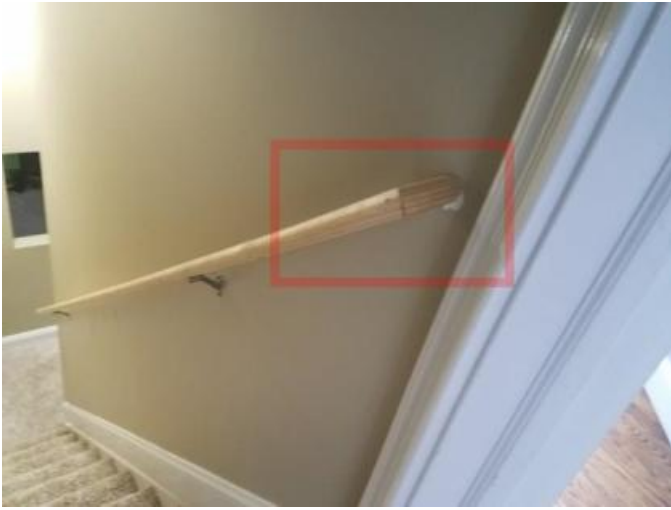
The staircase to the basement level appears functional. There are handrails attached and in useable condition. The staircase is lighted. *Attention Needed - Some portion of the staircase needs attention to perform satisfactorily. The handrail is loose and not properly supported. Repairs or adjustments are required.*

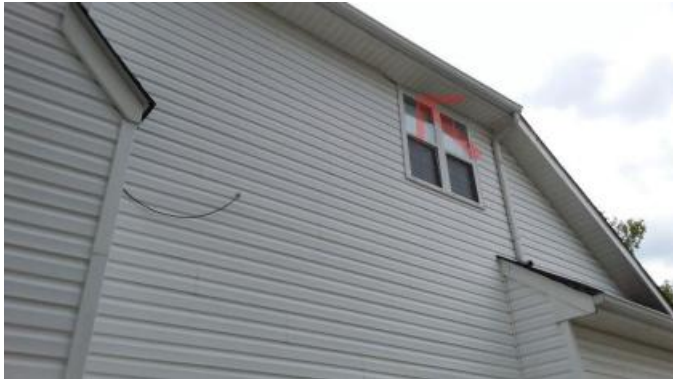
Action Necessary - Action is needed on the soffit and/or eaves as they are in a deteriorated condition and not performing their designed function. Some of the soffit panels on the left side of the house have become dislodged and are hanging loosely. The panels need to be re-seated.

Estimated Range of Costs to Repair or Remediate = \$350 to \$450

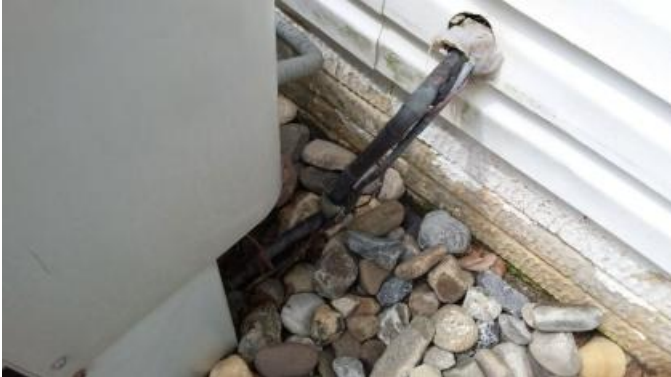
Action Necessary - The insulation wrap for the suction line to the condenser/compressor is either missing or needs replacement. This condition affects the efficiency of the cooling system.

Estimated Range of Costs to Repair or Remediate = \$50 to \$75

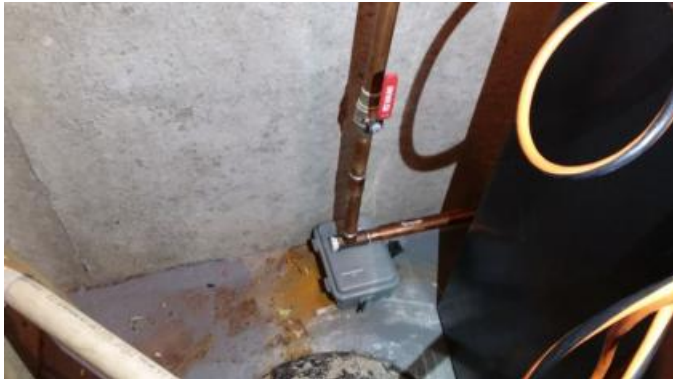
Action Necessary - The support straps and hangers are missing at the water supply line for the Iwan sprinkler system and there is action needed to prevent collapse or breakage.

Estimated Range of Costs to Repair or Remediate = \$150 to \$250

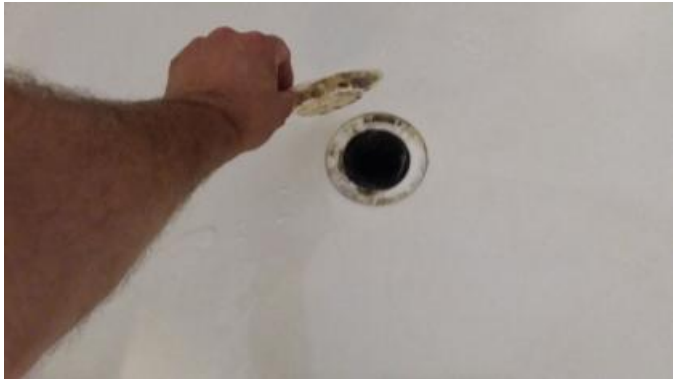
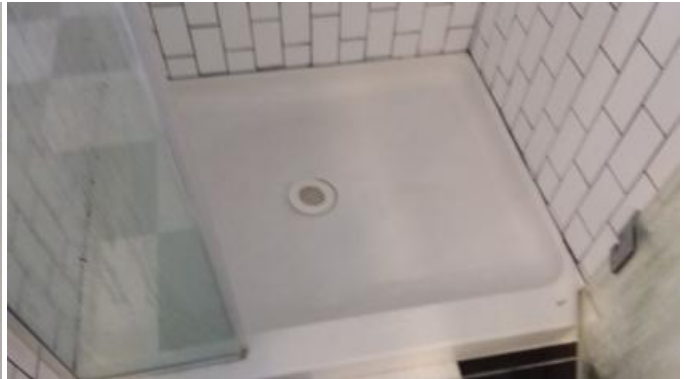
Action Necessary - The shower drain cover is loose and does not properly seat on the drain. Repairs are required to properly attach the drain cover on the drain line in the shower pan.

Estimated Range of Costs to Repair or Remediate = \$75 to \$150

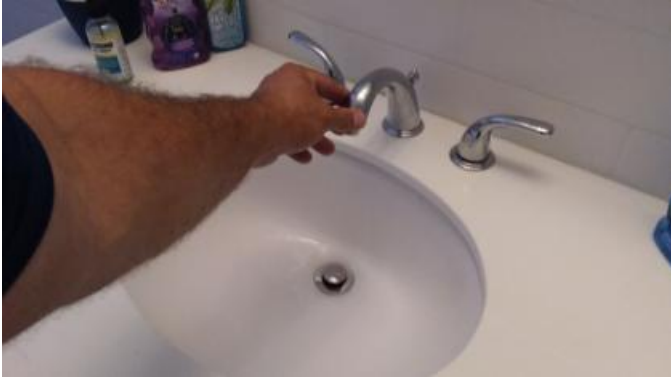
There are shutoffs installed for both hot and cold water pipes under the basin. **Action Necessary - The faucet assembly is not anchored securely to the countertop. The faucet moves on its base. The faucet body should be securely anchored to the countertop.**

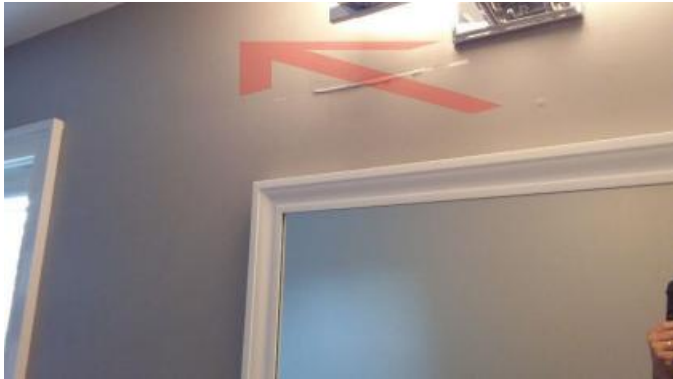
Attention Needed - The walls in this bathroom show some minor cracks. They do not appear to be a serious structural concern at this time.

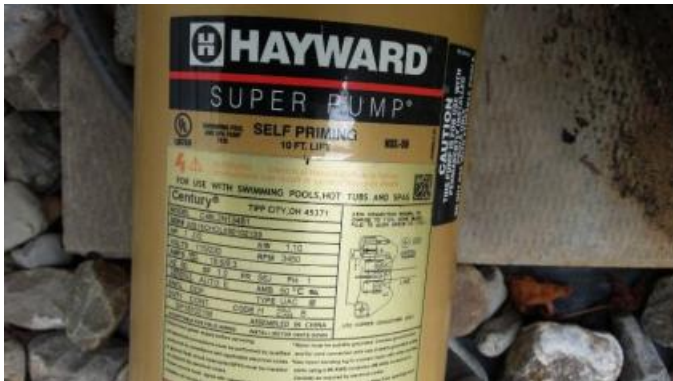
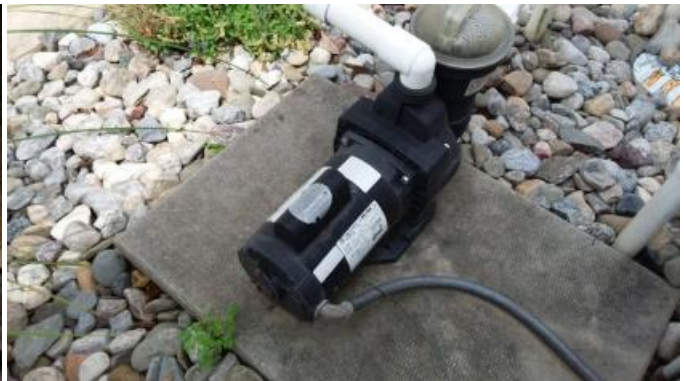
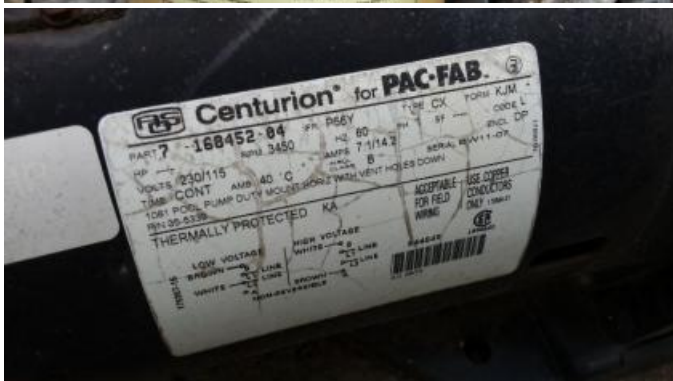
Pumping Equipment:

Pump Motor Manufacture Date:
Unknown. Appears newer.

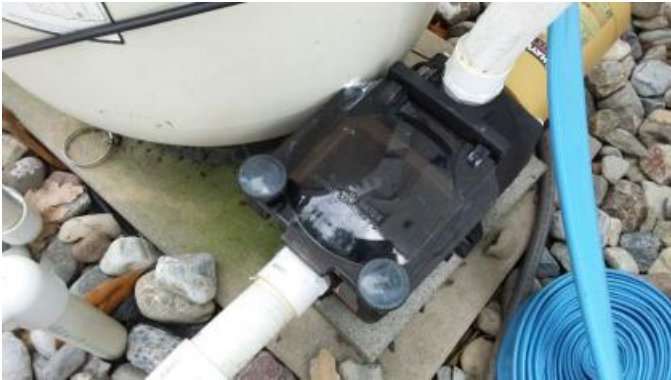
Hair/Lint Filter:

Good- no significant air bubbles noted.

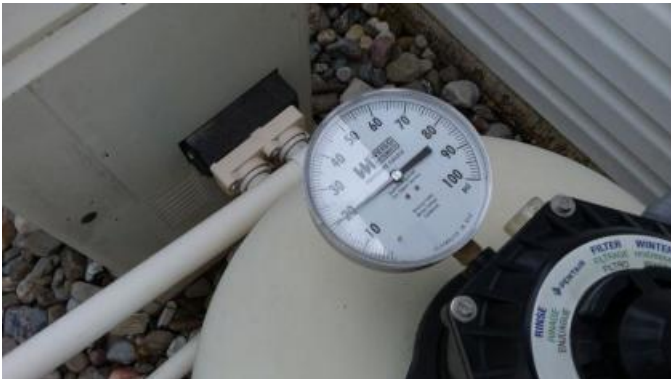
Pressure:

The pressure gauge indicated normal pressure between 10 and 20 PSI.

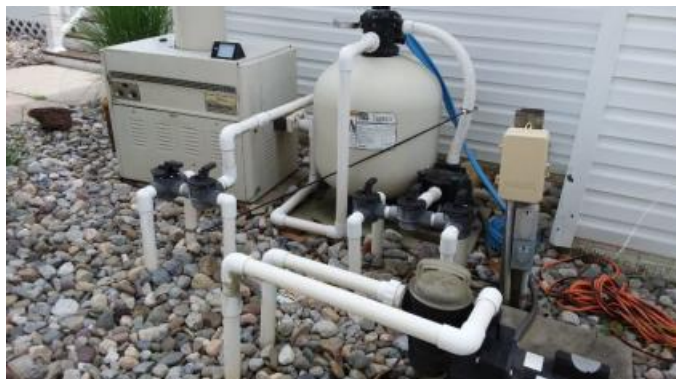
The visible plumbing lines were all in satisfactory condition with no signs of leakage.

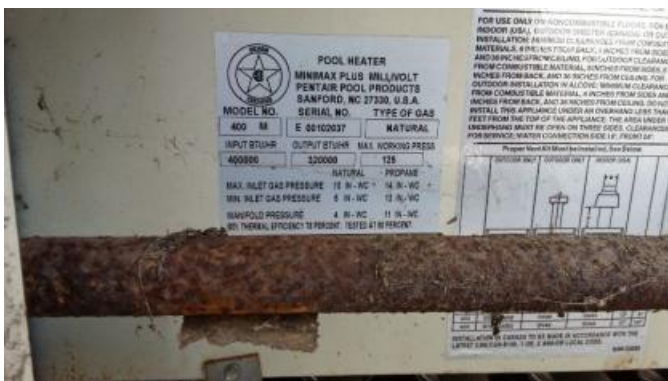
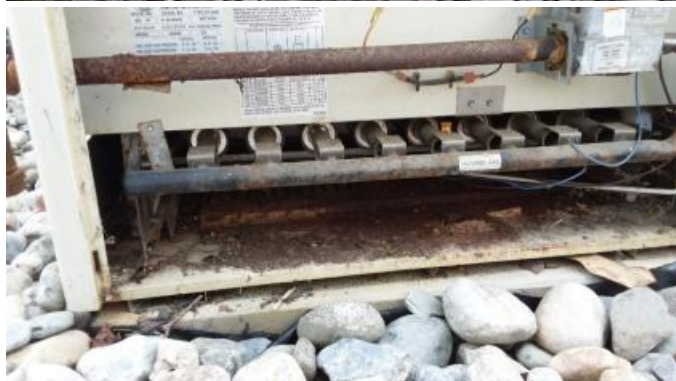
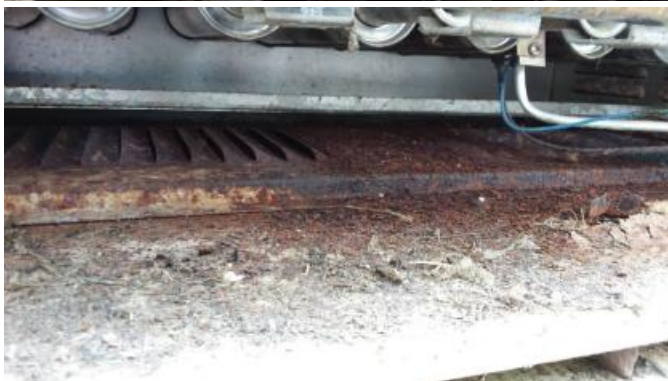
Type & Condition:

Natural gas. System has rusting within and is in fair condition, primarily due to its age. System operated properly at the time of inspection.

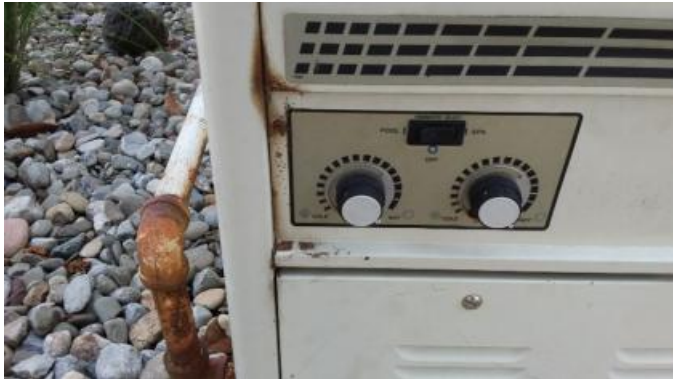
Gas Supply:

The gas supply was natural gas that had been hard piped from the structure. There was a shut-off valve located at the heater.

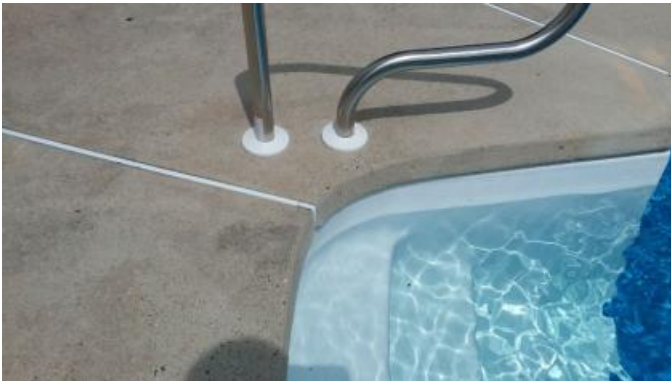
Child Protection Fencing:

Action Necessary - Holes in the deck posts indicate a child barrier on the deck was installed in the past. The deck gates have been removed negating the child barrier from the deck. There was also no door alarm on the sliding glass door. Make inquiry with the seller about the whereabouts of any fencing materials and check with the local town Building Department as to fencing requirements with regard to the swimming pool.
