### Confidential Stucco Inspection Report

This Property Inspection was completed on August 11, 2017

**Report:** 1234 Not A Real Street, Philadelphia, PA, 19101

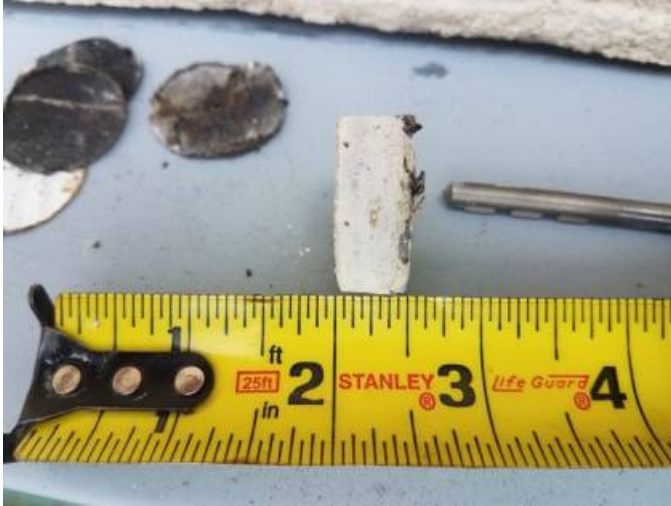
**System Thickness:**

The thickness of the system was measured either by core sampling or the removal of an attachment or by moisture probing. The system thickness was found to be 1/2" - This is considerably less than the ASTM minimum standard. This system thickness is an approximation based on the limited sampling taken. The system thickness can vary greatly. The ASTM minimum standard for traditional hardcoat stucco is 7/8". The ASTM minimum standard for the base of an adhered stone veneer system is 3/4". EIFS and other synthetic system each have a minimum standard based on the type of system and substrate utilized.

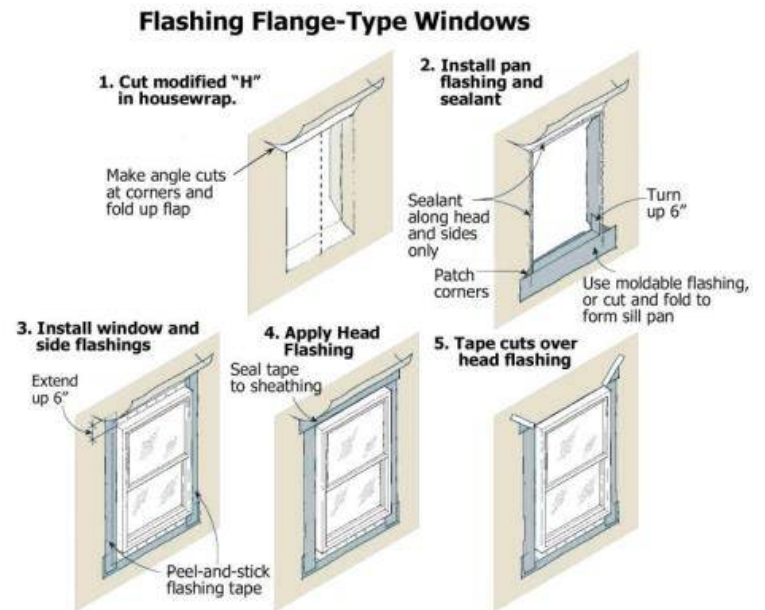
**Window and/or Door Pan Flashing Retrofit Recommended:**

The rear sliding glass door, with high moisture readings and/or soft substrates, should be removed to expose the structural components. Structural repairs should be made to replace any rotted members and sheathing. New pan flashing should be installed on the rough opening frame. The pan flashing should be sloped to allow proper water runoff and should provide a weep system. The pan flashing should be water-tight. After the pan flashing is installed, the door system should be reinstalled as per manufacturers installation details. The perimeter of the frame(s) should be sealed using self-adhered butyl flashing. The stucco system should be reinstalled in accordance with ASTM standards.

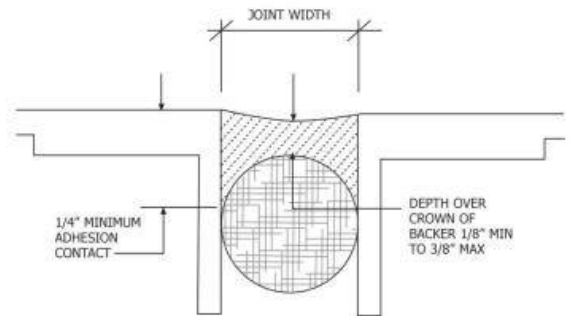
**Caulking & Sealant Recommendations:**

Stucco industry details require soffits/fascia/rake boards to lap over the masonry cladding by a minimum of 1". If this standard is not met, these terminations with the cladding system must be sealed to prevent moisture intrusion due to wind-driven rain.

Comprehensive Sealant Application - All joints and gaps between stucco and dissimilar materials must be sealed (i.e. stucco to wood, metal, concrete, stone, vinyl, etc.). All utility breach locations around the building need to be caulked. This includes, but is not limited to, pipe and wire penetrations, outlets, vent covers, HVAC penetrations, utility boxes and any other type of penetration. Seal the perimeter of all light fixtures leaving an opening at the bottom of the mounting plate for weepage. Seal ALL penetrations including downspout fasteners and the holes for the shutter plugs which attach the shutters to the cladding system.

The minimum width and depth of any sealant application should be ¼" by ¼". The depth of sealant may be equal to the width of joints that are less than 1/2" wide. For joints ranging from ½" to 1" wide, the sealant depth should be approximately one-half of the joint width. The maximum depth of any sealant application should be 1/2" (13 mm). If the joints are larger than 1" contact the caulking manufacturer for guidance. Backer rods or bond breaker tape should be used for all joint applications.

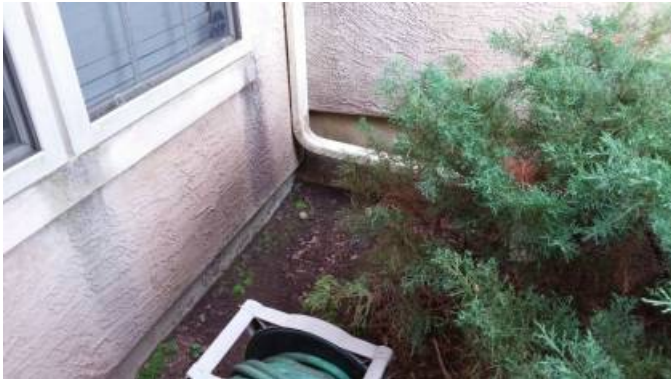
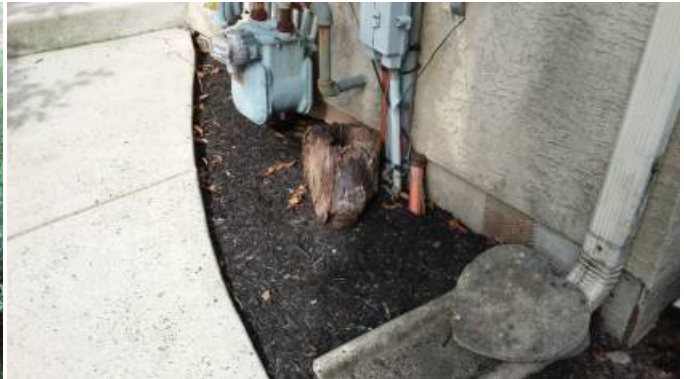
#### **Stucco Grade Terminations**

Stucco industry details require a minimum ground clearance of 4" above landscaping. Stucco is properly terminated above grade as depicted in the attached photos.
